Technical Report HL-96-22
December 1996

Demonstration Erosion Control Project Monitoring Program

Fiscal Year 1994 Report

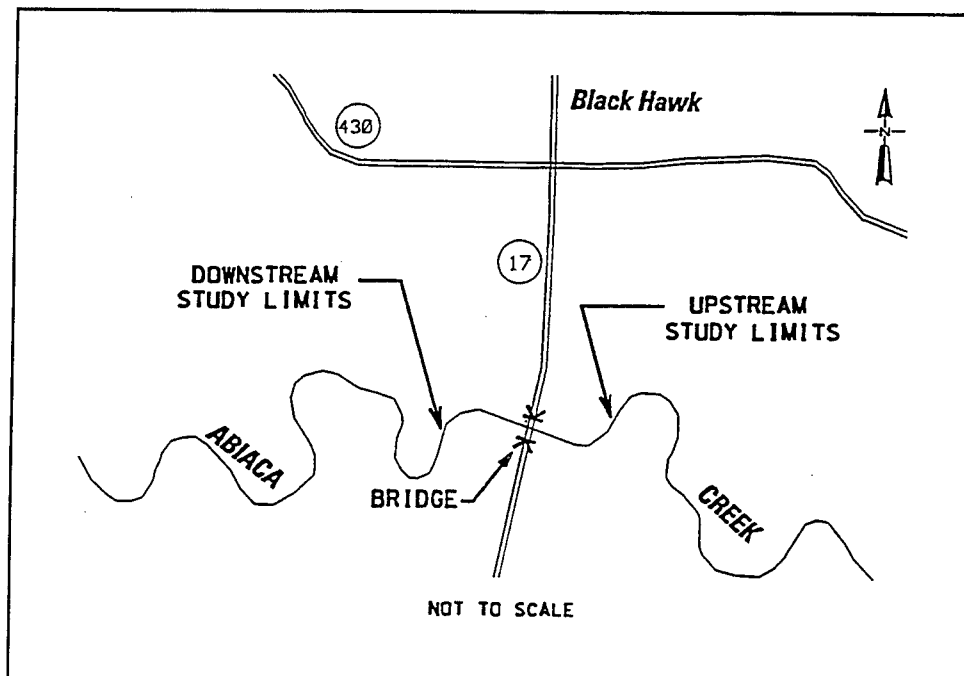
Site 3, shown in Figure 4, is located in T17N, R3E, Section 20, at the Highway 17 crossing of Abiaca Creek. The approximate watershed area at this site is 26.5 square miles. This site was selected because of the relative stability of the channel at this location, and the fact that it is upstream of the gravel mining location. The streambed at Site 3 is composed primarily of sand with minor amounts of gravel. The banks are generally well-vegetated with mature vegetation down to the low-water surface; however, erosion of the outside bank of the bendways was noted. There is notable bank erosion on the upstream portion of this site extending upstream of Highway 17 where a bend is actively migrating. This is a local erosion situation, with no indication of overall system instability. Bioengineering methods could be used to stabilize these sites. The thalweg profiles (Figure 5) indicate that local variation, primarily scour, has occurred on the order of 2 to 3 ft vertically.

Figure 4. Abiaca Creek, Site 3

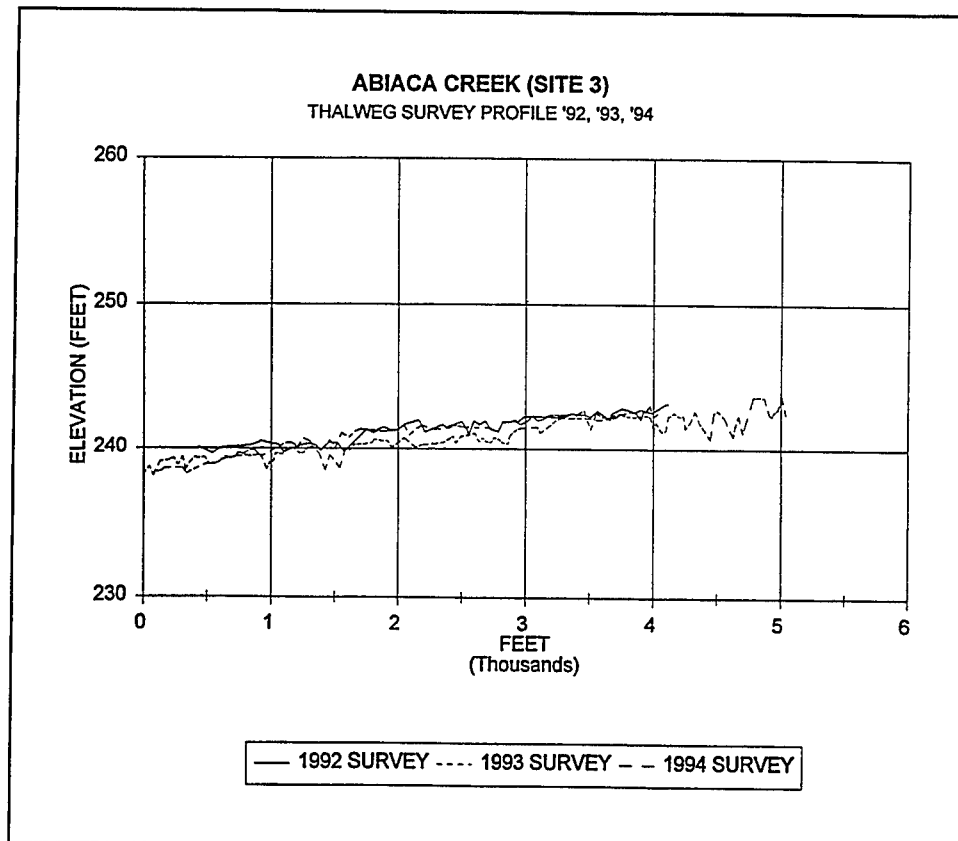
Figure 5. Abiaca Creek, Site 3, thalweg profile

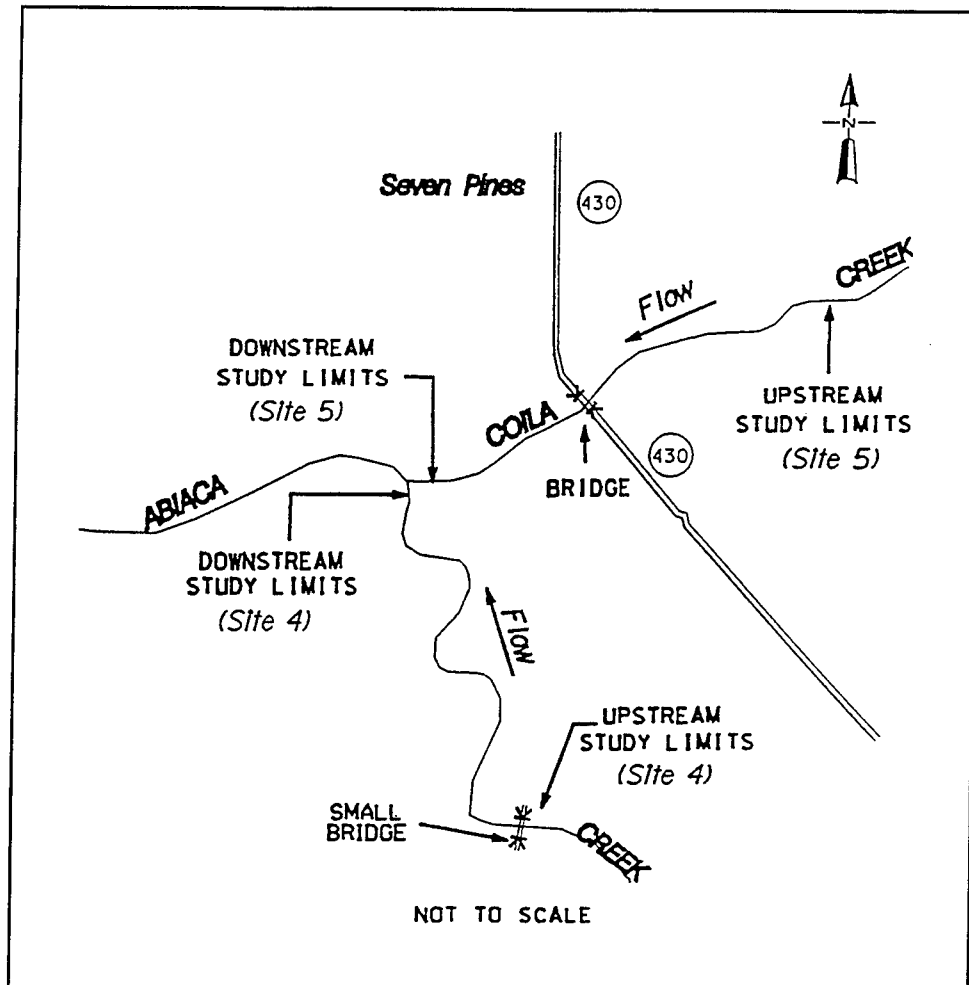
Site 4 is on Abiaca Creek and extends approximately 4,000 ft upstream from the confluence of Coila Creek as shown in Figure 6. This site is located in T17N, R2E, Section 4, and has a watershed area of approximately 44 square miles. Site 4 is located approximately 1.8 miles downstream of a major sand and gravel processing operation that can be associated with an increased supply of suspended and bed material load. Streambanks in this reach are relatively stable and the bed gives the appearance of an aggraded reach. The most significant change in this watershed has occurred at the confluence of Abiaca and Coila Creeks, indicating aggradation since 1992 (Figure 7). During the October 1994 field inspection, Abiaca Creek flow was a milky, high suspended sediment load flowing into a relatively clear Coila Creek flow. The island immediately downstream of the confluence had shifted to a bar attached to the right bank, with all flow along the left bank. The downstream 500 ft of Coila Creek is actively eroding and the confluence may shift downstream by next year.

Figure 6. Abiaca Creek, Site 4

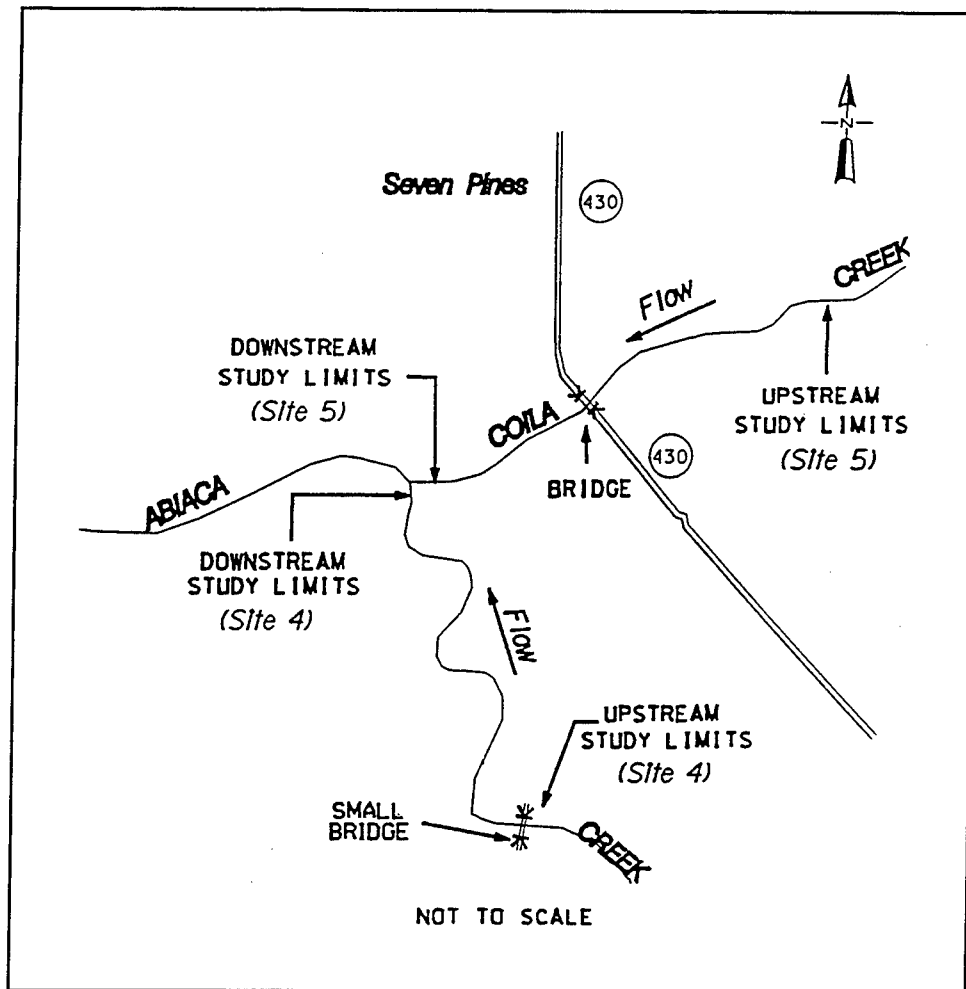
Site 5 is actually located on Coila Creek, but is in the Abiaca Creek watershed. The site extends upstream approximately 4,000 ft from the confluence with Abiaca Creek as shown in Figure 8 in T17N, R2E, Section 4. The site has a watershed area of approximately 42 square miles, very similar to Site 4, which allows the comparison of two almost equal size drainage basins. SCS reservoirs control a high proportion of the Coila Creek basin, and the gravel mines on Coila Creek are not as active as those along Abiaca Creek. The thalweg profile indicated that some aggradation has occurred on the downstream portion of this site with little or no changes in bed elevations for the remaining portion (Figure 9).

Figure 8. Coila Creek, Site 5

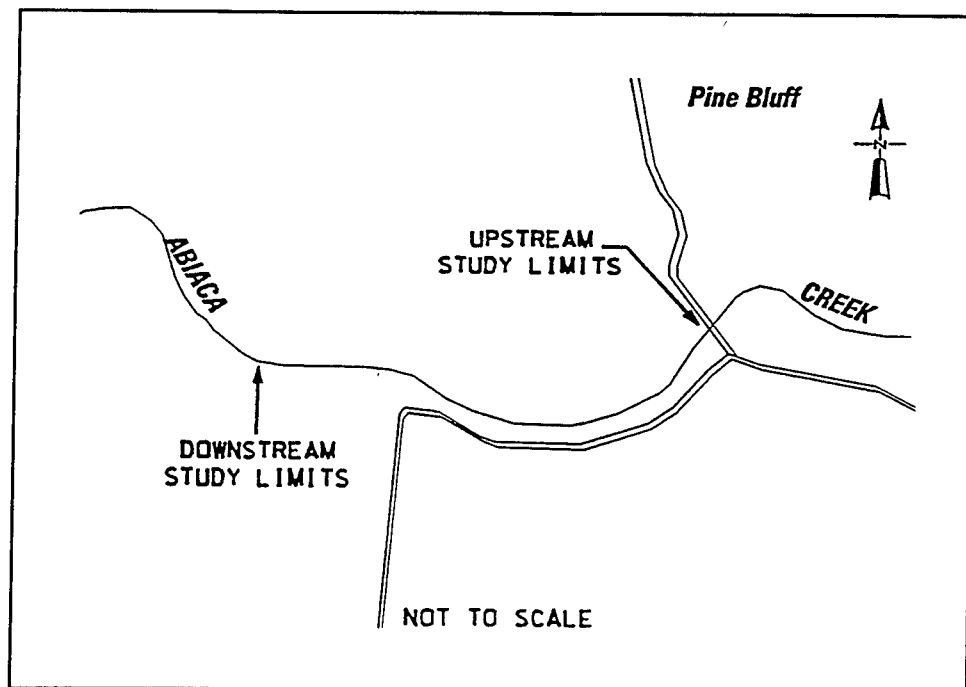
Site 6 is located on Abiaca Creek where the stream emerges from the hill line into the flatter Yazoo Delta in T17N, R1E, Sections 13 and 14, as shown in Figure 10. The drainage area at this location is approximately 99 square miles. This is also the site of the Pine Bluff gauging station with records from 1963 to 1980. This station has been reactivated and includes a

Figure 10. Abiaca Creek, Site 6

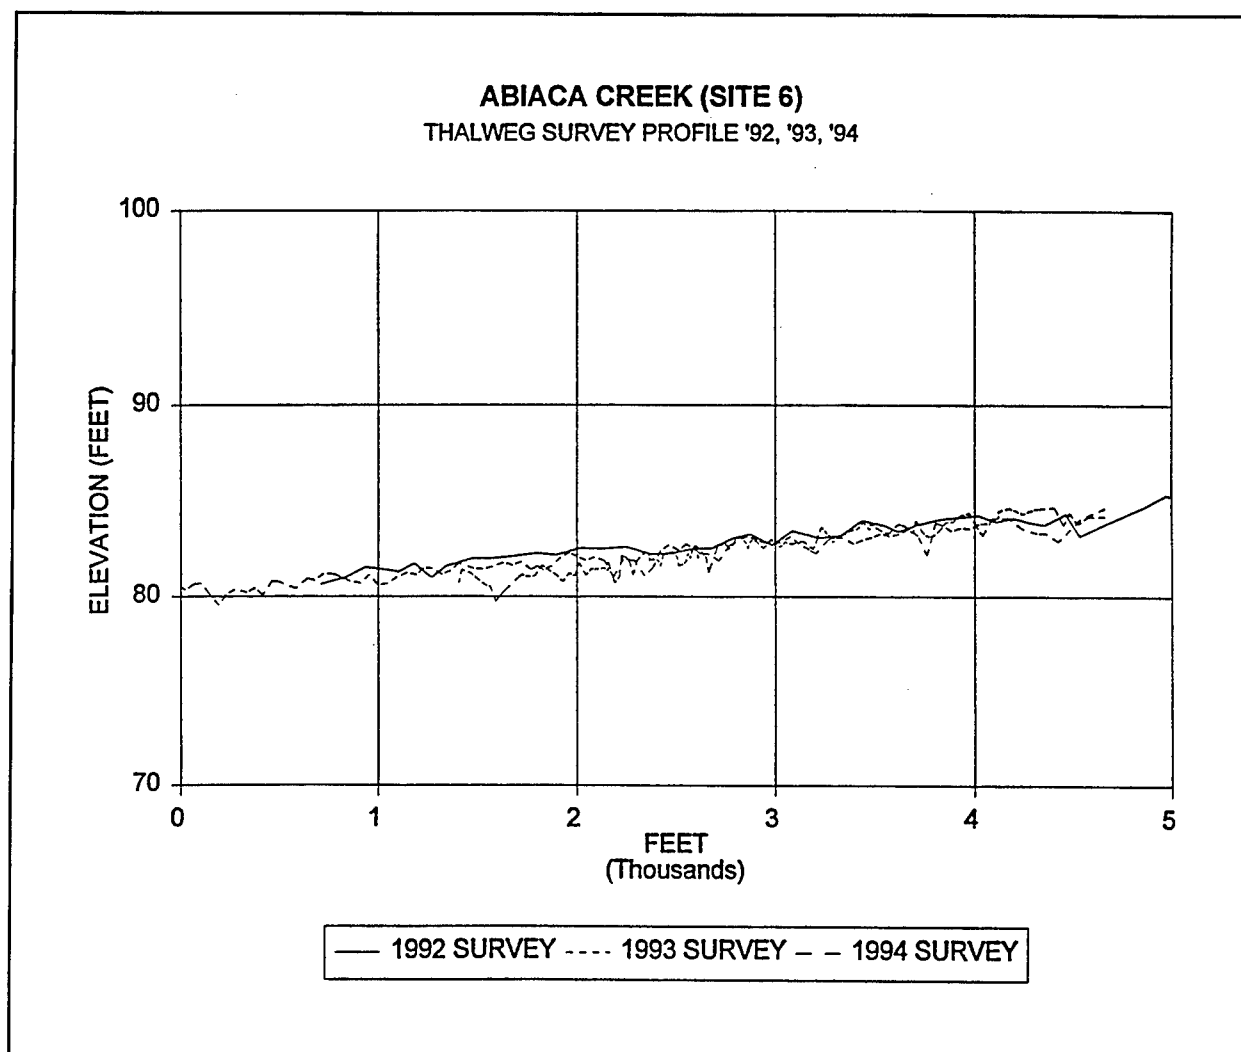
pumped sediment sampler. The study reach extends approximately 4,000 ft downstream of the Pine Bluff gauging station. The thalweg profiles (Figure 11) indicate that local variation, primarily scour, has occurred on the order of 2 to 3 ft vertically.

Figure 11. Abiaca Creek, Site 6, thalweg profile

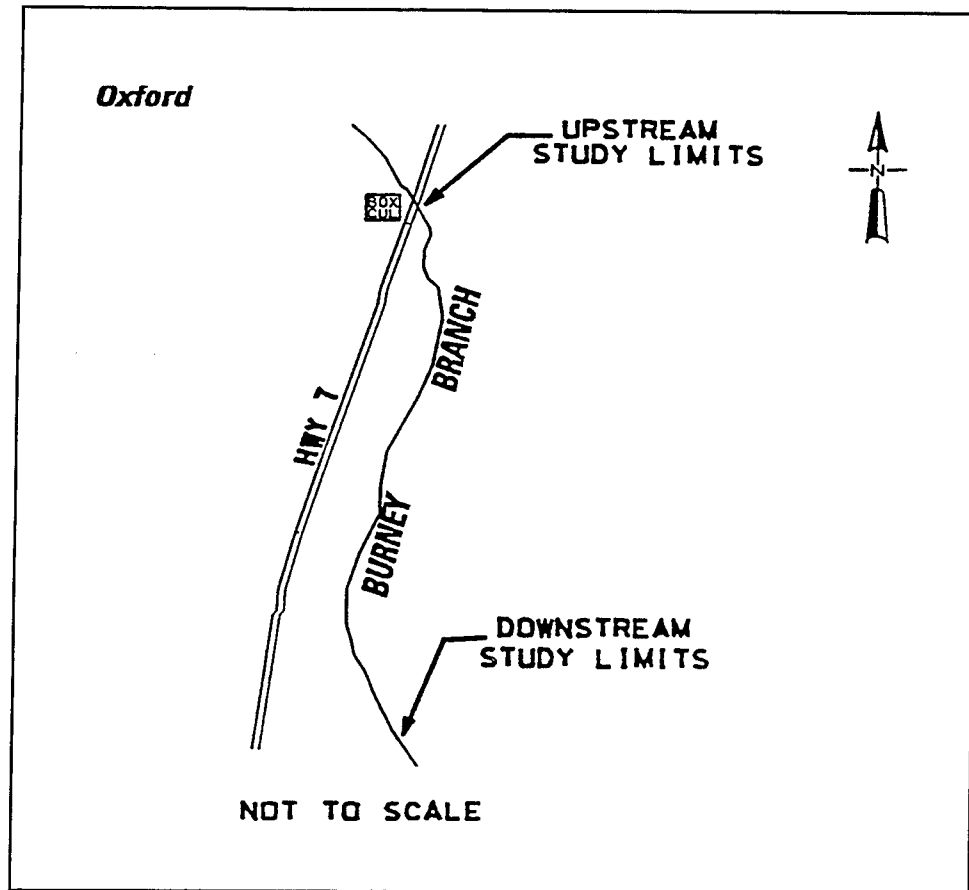
Site 12 (Figure 14) is located on Burney Branch near Oxford, MS. The study reach begins at the Highway 7 crossing of Burney Branch and extends downstream for a distance of approximately one mile through a reach containing two SCS high-drop structures. Burney Branch has a drainage area of approximately 10 square miles at this location. The site can be located on the Oxford quadrangle map, T9S, R3W, Sections 4 and 9.

The two high-drop structures have been very successful in rehabilitating this reach of Burney Branch. Both structures were constructed in 1982. These structures were designed to contain the 100-year discharge and include the

Figure 14. Burney Branch, Site 12

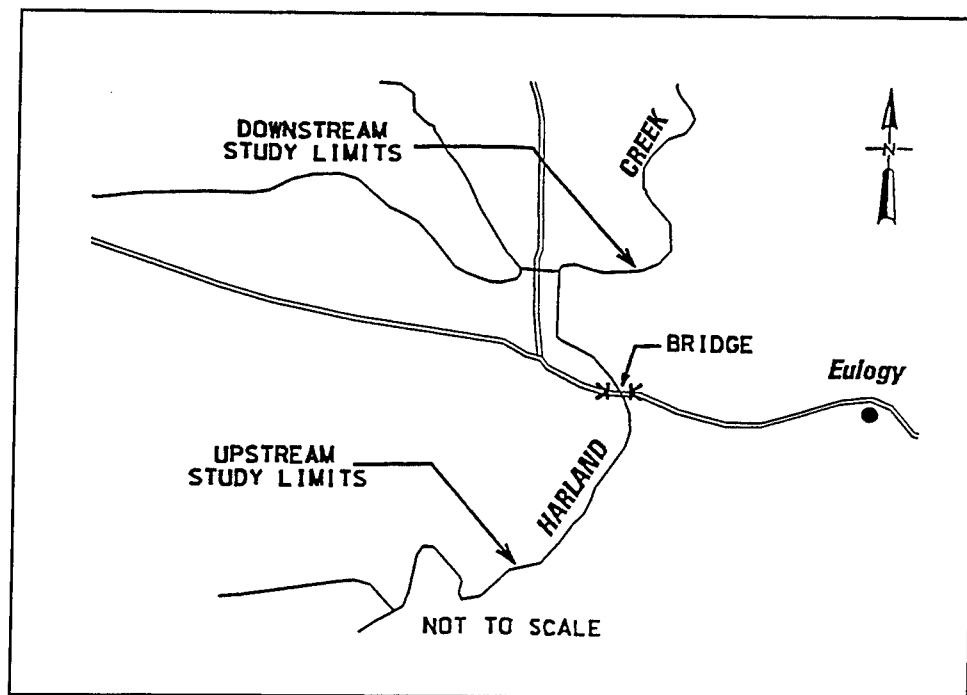
Figure 18. Harland Creek Site 1

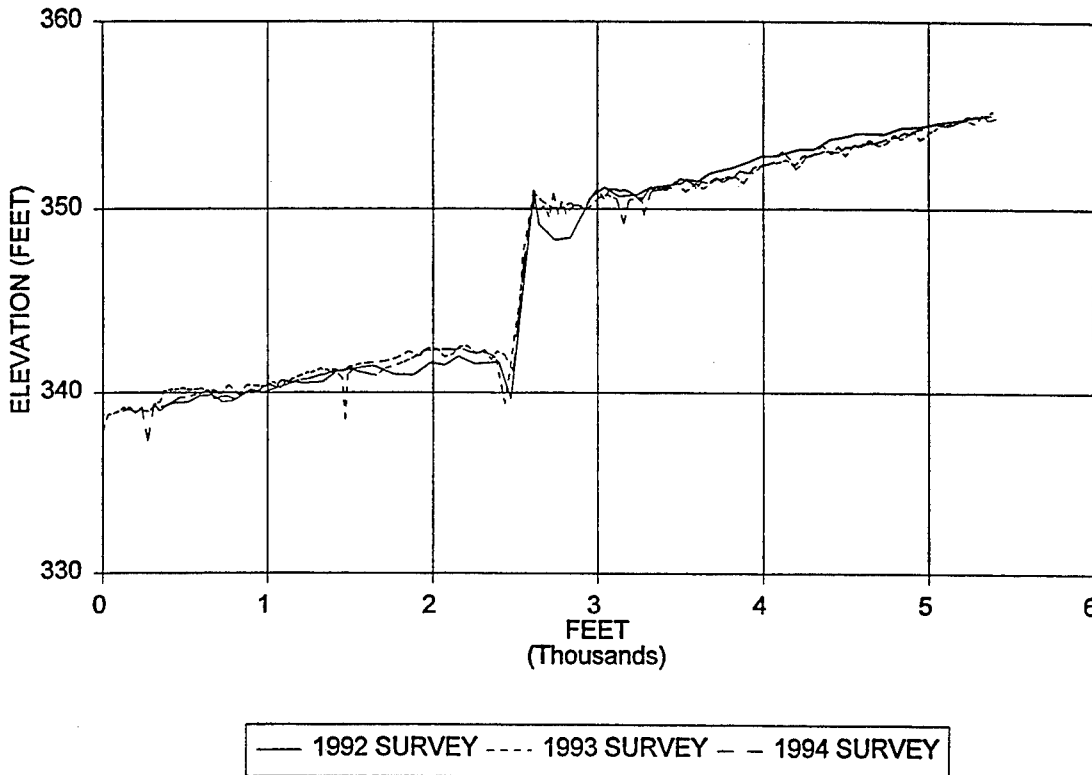
Figure 27. James Wolf Creek, Site 19, thalweg profile

The thalweg profile (Figure 27) indicates that no significant change has occurred during the past three surveys. The upstream scour feature has completely filled for the 1993 and 1994 surveys. A large beaver dam exists on the upstream riprap approach. Apparently, the beaver prefer the riprap foundation for their construction site. A backwater condition exists from the beaver dam to the upstream tributary on the left bank at approximate station 33+00. About 250 ft downstream from the upstream bridge, willows are establishing on an island in the center of the channel. Heavy kudzu growth dominates the bank vegetation. Riprap movement at the structure has been severe over the years and is continuing. No movement or cracking of the weir cap was noted.

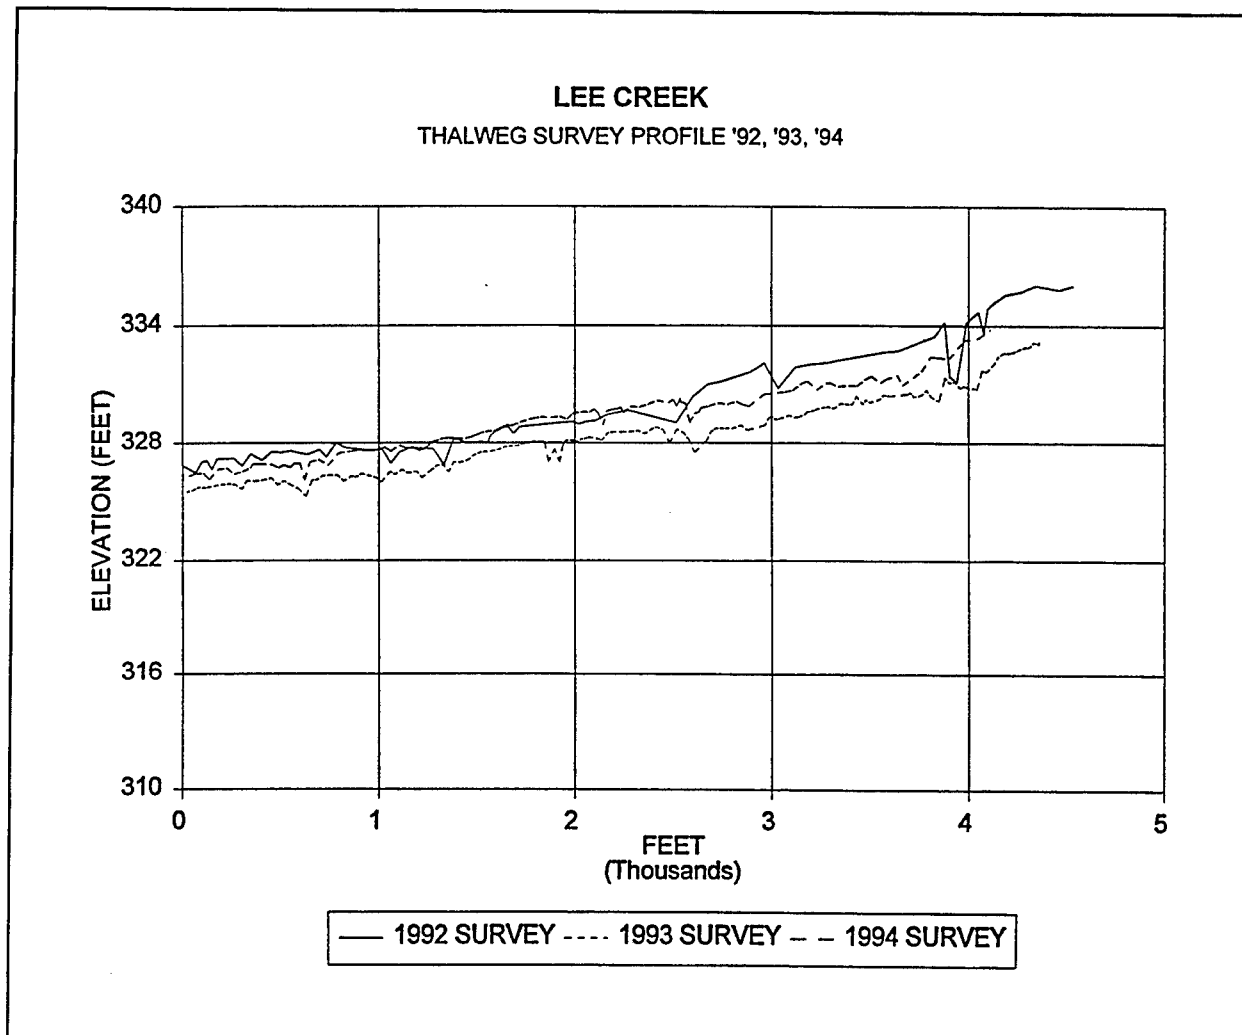
Figure 29. Lee Creek, Site 10, thalweg profile

Based on the channel profiles (Figure 29), from 1992 to 1994 channel degradation in the range of 2 to 4 ft occurred. Any channelization of the upstream portion of the site should include extending the survey upstream and consideration of grade control. BURBANK analysis confirms the field observations that the channel banks are stable. The 2-year water surface slope of the reach is 148 percent of the slope and 177 percent of the width for the width and slope required to transport 1,000 mg/l at minimum slope, as defined by SAM (Table 16).

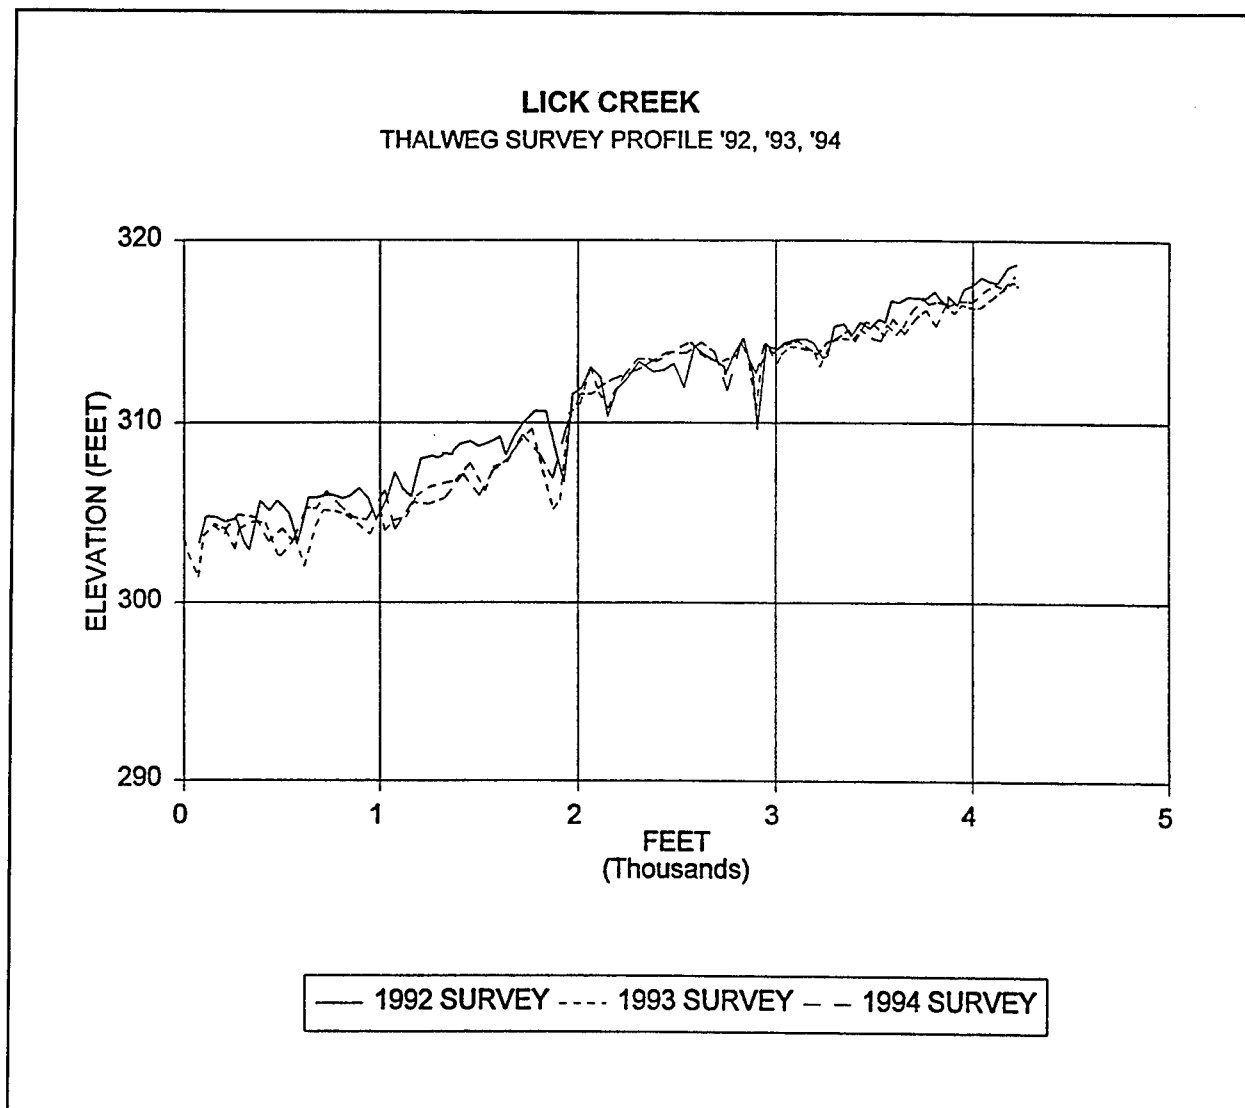
Figure 31. Lick Creek, Site 8, thalweg profile

The high-drop structure is located at approximate station 18+00 of the accompanying thalweg profile (Figure 31). Riprap placed at the bridge (station 20+00) as a temporary measure during construction of the structure has slowed the incision that is continuing upstream and downstream of the bridge. Degradation is continuing downstream of the structure and can be expected to continue after the closure of the structure. Backwater from the structure should assist in halting the upstream incision if the knick zones have not progressed too far upstream to be affected by the high-drop. The high-drop structure will protect the highway bridge. Presently, the upstream extent of the site is incising into resistant clay.

BURBANK analysis indicates that 3 ft of additional degradation will destabilize 19 percent of the surveyed banks. Left bank drainage upstream of the bridge is poor, with standing water in the adjacent field. Channel incision and a saturated left bank may combine to result in greater instability than in other similar streams. A drop pipe could be added to improve the bank drainage in that area. The SAM analysis indicates that the width has been increasing and the slope has been decreasing since the initial 1992 survey.

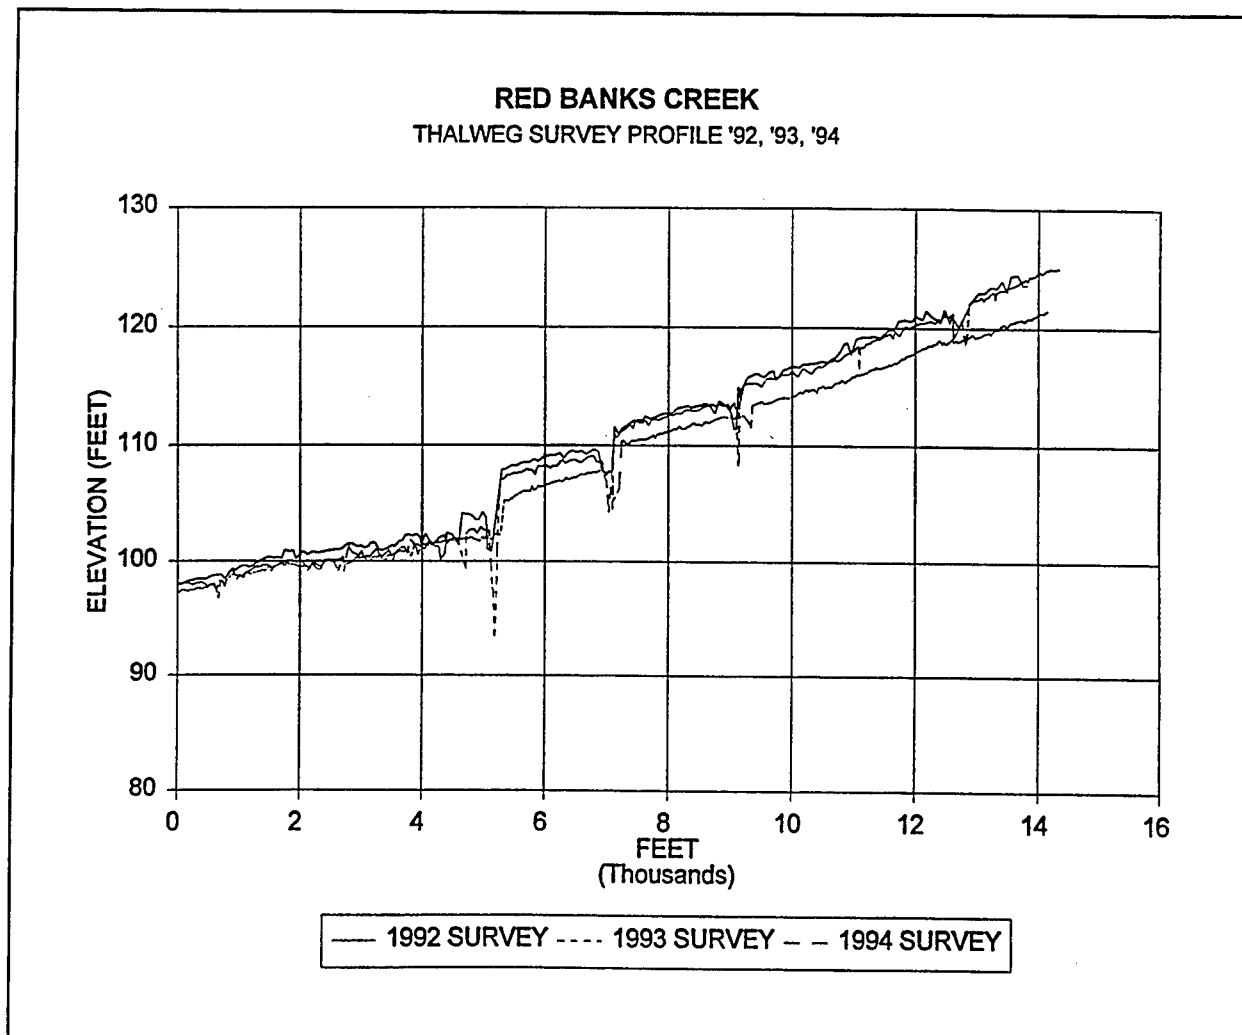
Figure 41. Red Banks Creek, Site 9, thalweg profile

As shown in the accompanying thalweg profile (Figure 41), Red Banks Creek has been dynamic during the 1992 to 1994 study period. Prior to 1992, 2 tons per linear foot longitudinal riprap and four riprap chevron weirs were placed in the study reach. The channel was narrowed significantly at the downstream bridge and immediately upstream of the bridge for a distance of approximately 100 ft. Degradation in the range of from 1 to 3 ft is shown from 1992 to 1993 and to 1994 downstream of the chevron weirs. Approximately at station 50+00 a headcut was observed in 1992 and 1993. The pool downstream of the most downstream chevron weir was surveyed to be in excess of 10 ft in depth and increased in depth during the 1992 and 1993 period. During the 1994 thalweg survey, degradation had occurred and the riprap of this

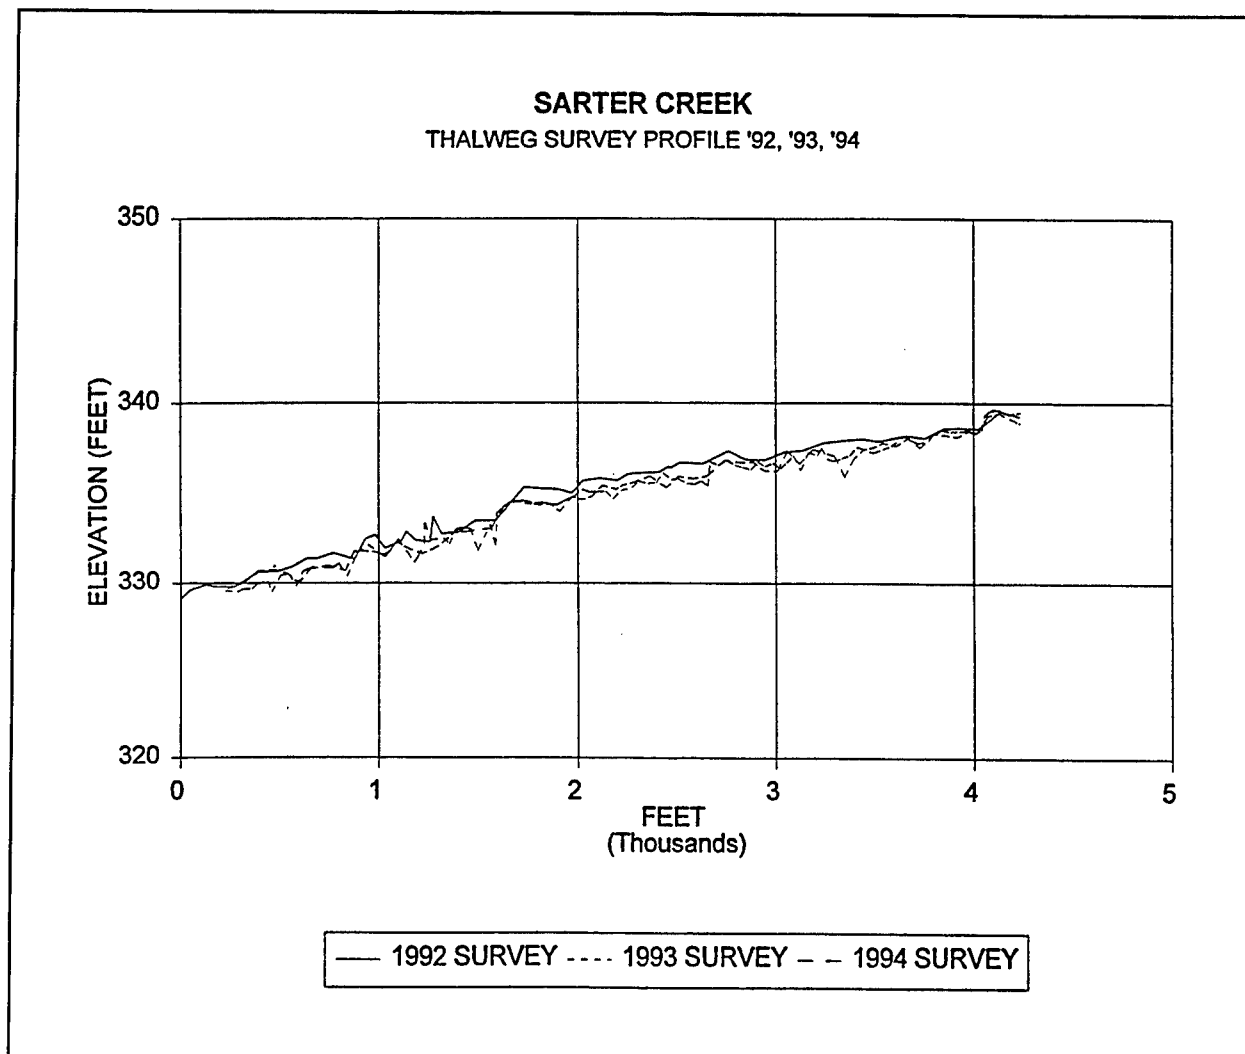
Figure 43. Sarter Creek, Site 15, thalweg profile

BURBANK analyses indicate that the banks are not yet geotechnically unstable (Table 23). The SAM analyses indicated that the average width and

slope are remaining constant at about 117 percent of the width and 170 percent of the slope required for minimum stream power for the transport of 1,000 mg/l.

In general the bank stability remains good because the bank height is low, but the degradation potential is high. The channel is relatively small, only about 30 ft in width, and consideration should be given to testing lower cost grade control structures, such as gabion structures, to stabilize the channel.

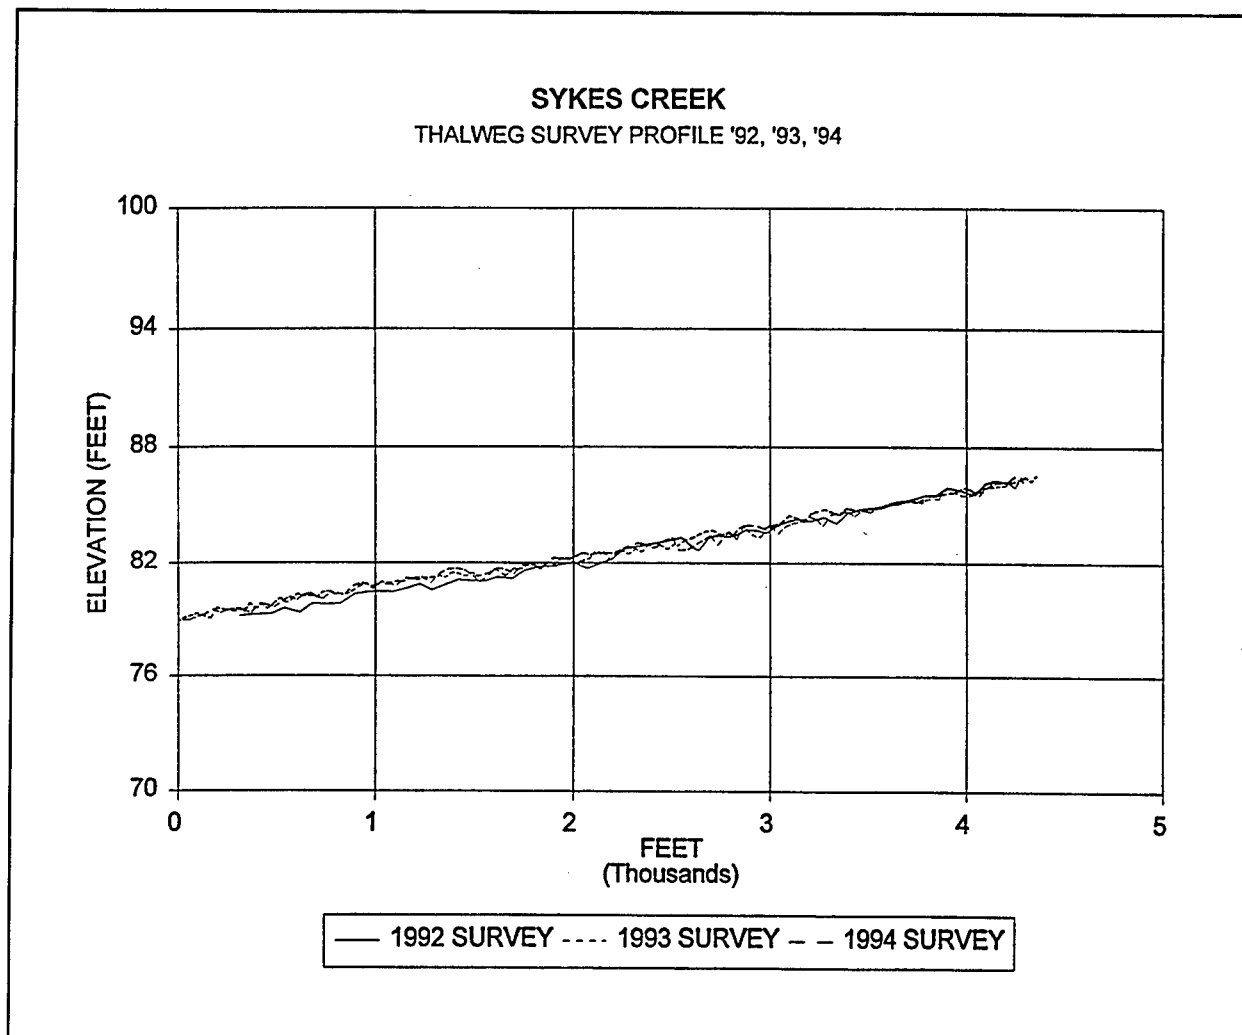
Figure 45. Sykes Creek, Site 17, thalweg profile

The accompanying thalweg profile (Figure 45) indicates that little change has occurred during the 3-year period. Several factors relative to the site, such as berm formation, depth of sand in the bed, and thalweg comparison, indicate that the channel could be considered in quasi-equilibrium. However, comparison of the existing conditions with the slope and width required at minimum stream power for transport of 1,000 mg/l indicates that the reach is transporting a relatively high sediment load. Based on the 1994, 2-year flow, the water surface slope is 235 percent of the minimum slope and the width is 70 percent of the width at minimum slope (Table 24). Also, the BURBANK analyses indicated that approximately 40 percent of the channel banks are unstable if degradation of 1 ft or more occurs.

About 300 ft upstream of the county road bridge a large, tight bend is active and in the process of producing a channel cutoff. During the present monitoring program the point bar chute has progressively enlarged, and the upstream approach has become more abrupt. At the same time the old channel has become increasingly choked by debris. Presently the upstream approach bend is eroding heavily into a residential lot, and, following the cutoff, the banks adjacent to a downstream hayfield will probably erode. The alignment to the downstream bridge is presently relatively straight, and the new alignment is uncertain. The cutoff will increase the slope locally and may cause upstream

degradation. To fully evaluate the short- and long-term impacts of the changes occurring in this reach, consideration should be given to identification of upstream sediment sources, remedial measures to reduce sediment supply, possible future grade control, reduction of the slope and the bank height, and attention to the bridge alignment.

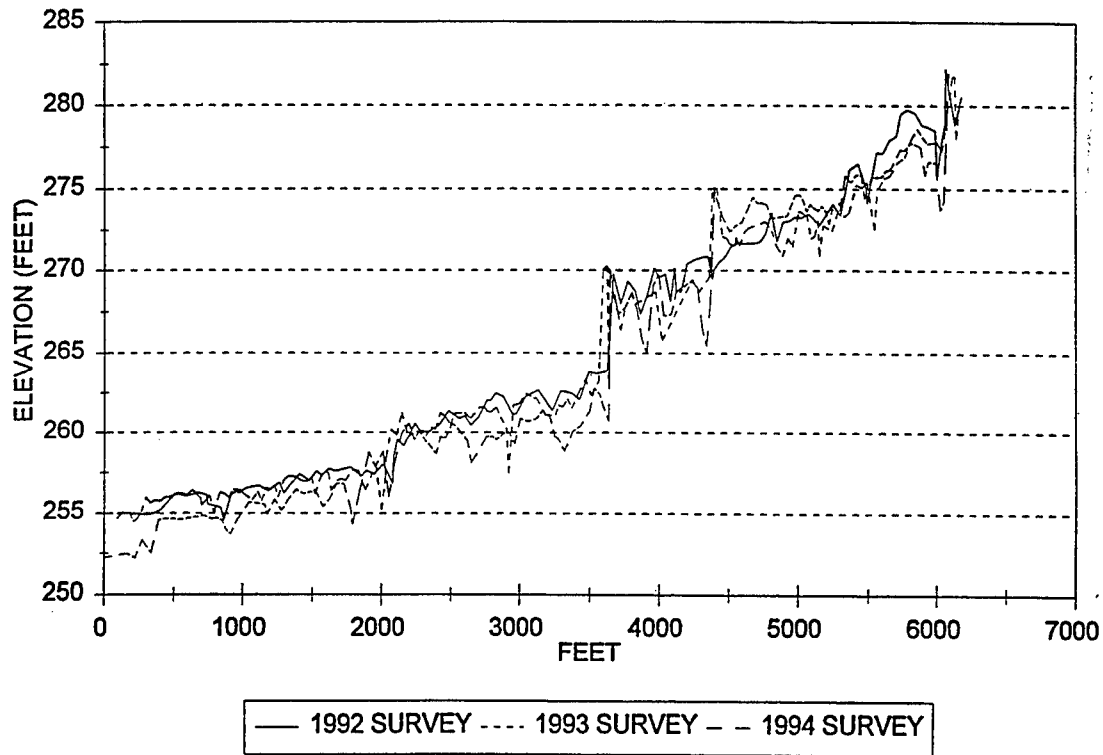
Figure 47. East Worsham Creek, Site 18a, thalweg profile

The downstream extent of the reach defined as East Worsham Creek (Site 18a) is the confluence of Worsham Creek with Middle Worsham, which is the first confluence downstream of the highway bridge. The thalweg profile indicates the locations of the structures and the variations in the profile indicating a general tendency for this site to degrade over the present monitoring program (Figure 47).

The reach is divided into three segments. Segment 1 extends upstream from the confluence to the downstream, older structure. The short reach between the two structures was not analyzed separately. Segment 3 is upstream of the middle structure. A beneficial effect of the upstream grade control structures can be realized by comparing the percentage of bank at risk for the zero friction angle condition in 1994 (Table 25). Grade control has raised the channel bed to reduce the percentage of unstable bank from 98 percent in segment 1 to 0 percent in segment 3. This is a significant improvement. However, the 2-year slope in both segments remains very high at approximately 300 percent of the 1000-mg/l minimum slope. Fortunately, the segment 3 bed is composed primarily of very erosion resistant clay, and segment 1 includes numerous outcrops of ironstone and clay that provide a degree of vertical stability. Sediment transport in both segments is significantly controlled at lower discharges by beaver dams. The durability of the beaver

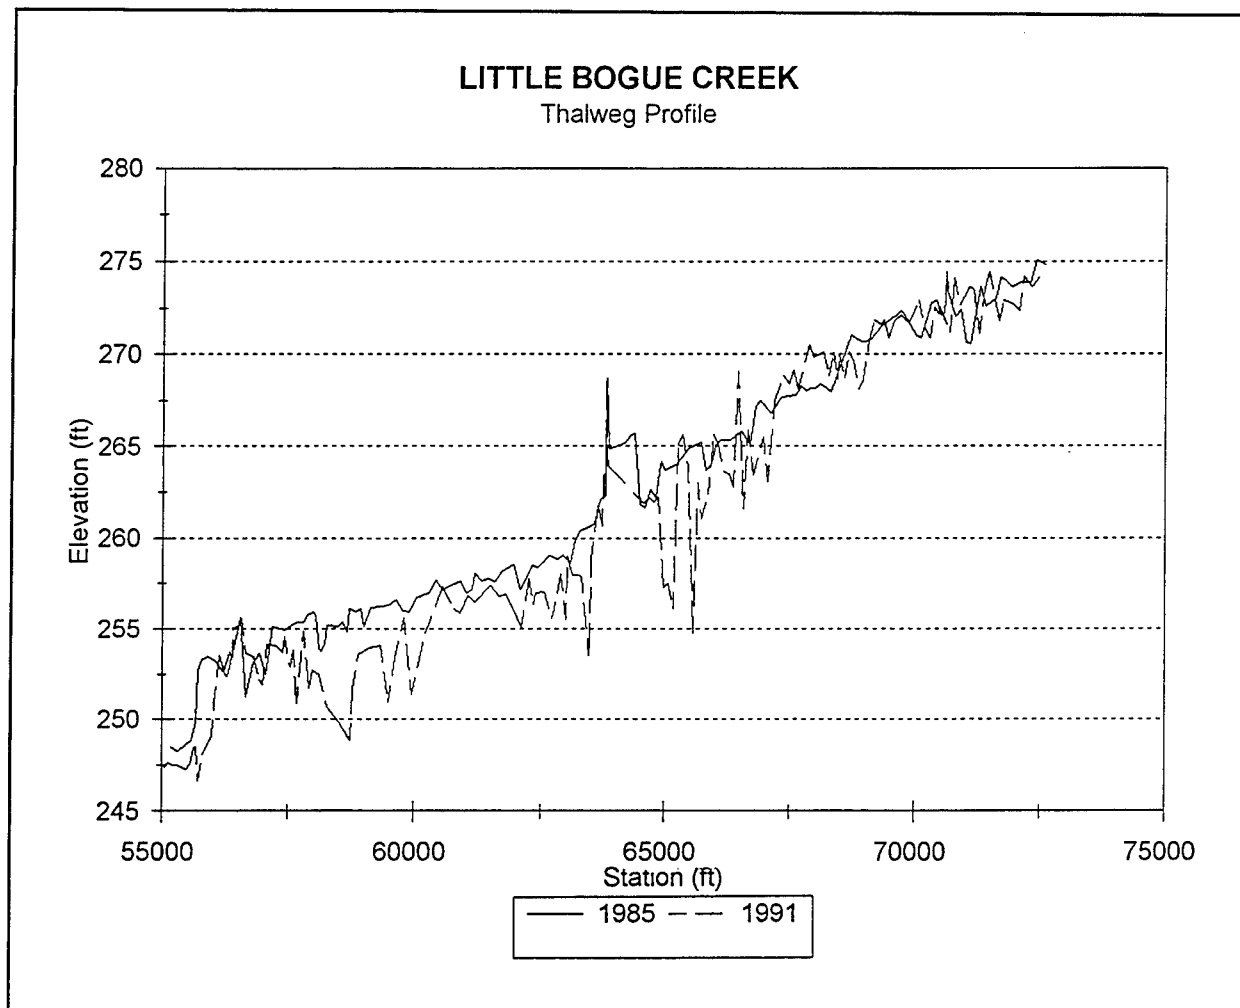
Figure 59. Comparison of 1985 and 1991 thalweg profiles

The thalweg profile (Figure 59) indicates that the bed has degraded between stations 570+00 and 625+00 during the period between 1985 and 1991. This may have been influenced by construction of the upstream grade control. The 1995 data indicate that changes between 1991 and 1995 were minor in the reach immediately downstream of the structure. Upstream of the structure some filling is noted; however, the bed remains below the original weir elevation for a distance of approximately 3,000 ft. Recent reconstruction of the

appearance upstream, with some berming along the toe of the bank and with more permanent vegetation. In this reach the riprap is resting on the upper surface of the shale outcrop, and the shale has been eroded approximately 3 ft vertically. Launched riprap does not remain on the shale surface and is transported downstream. As shown in the thalweg profile (Figure 59), the water depth upstream of the outcrop is relatively deep.

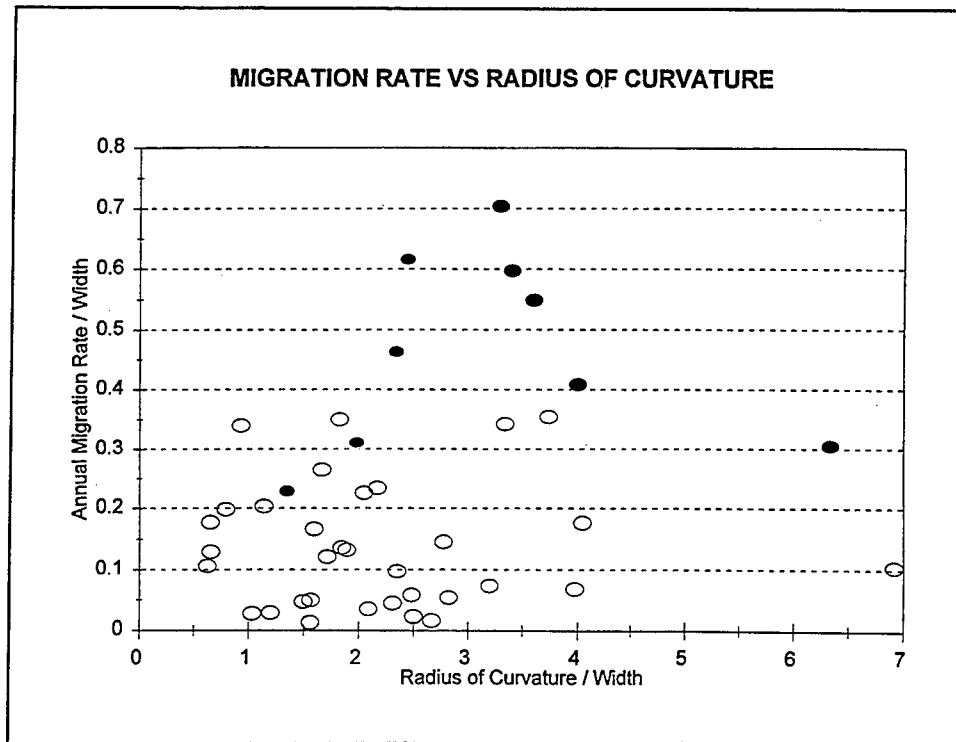
Figure 65. Harland Creek, bendway radius of curvature versus migration rate

Figure 65 is a plot of Harland Creek data showing the radius of curvature of the meander bends divided by the channel width on the x-axis, and the annual migration rate divided by the channel width on the y-axis. The dark, filled data points are representative of the upper envelope of data points for the Beaton River, British Columbia (Hickin and Nanson 1975). The envelope lines indicate that the maximum rate of channel bend migration occurs as the ratio of the radius of curvature to width (R_c/W) approaches a value of 3.0, or in a

broader range, for about 2.5 to 3.2. Bends in this range are rapidly altered to either a greater or less R_c/W , which have less dynamic rates of migration. Less than 20 percent of the Harland Creek data were found in the 2.5 to 3.2 range.

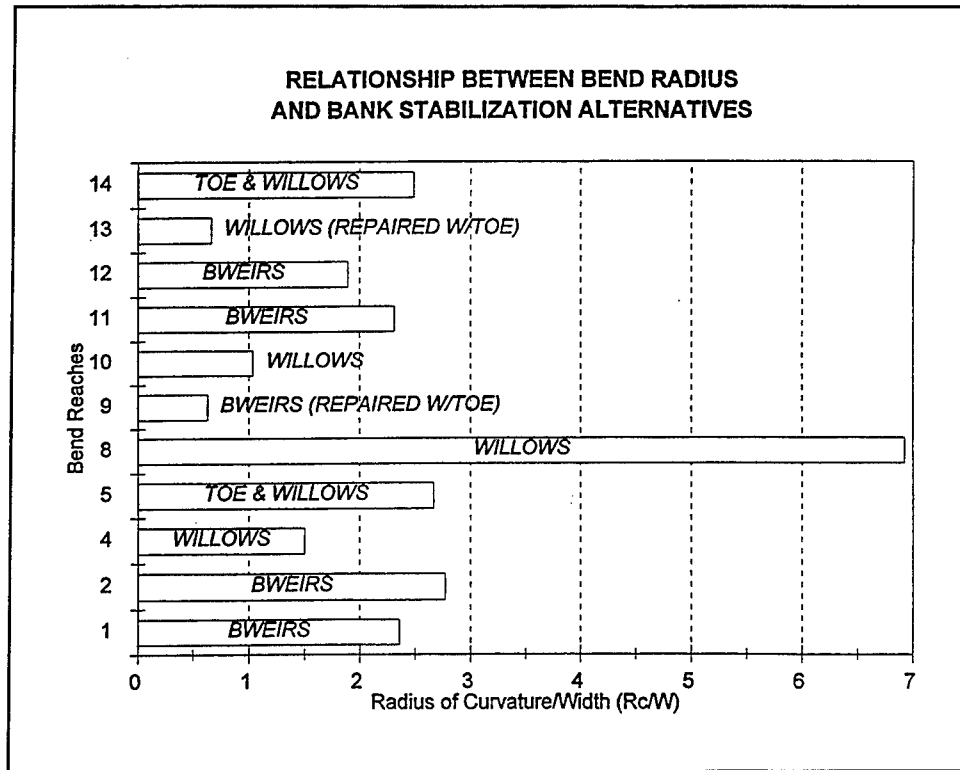
Figure 66. Relationship between R_c/W and bank stabilization alternatives

Figure 66 is a bar chart indicating the value of the radius of curvature to channel width ratio for each of the eleven bends within the fourteen stabilized reaches on Harland Creek. The labels on the bars indicate the type of stabilization that was emplaced. On bars 9 and 13, it is noted that the initial stabilization was repaired using a 2-ton-per-linear-foot longitudinal stone toe. The measured value of the R_c/W ratio was less than 0.65 for both of the bends requiring repair.

Reach 9 was initially stabilized using bendway weirs. Due to flanking of the weir and continued bank erosion at the downstream extent of the weir field, repair was made using the stone toe. Apparently, alignment and spacing of the bendway weirs, as constructed, were not adequate to control the erosion. It has been observed that traditional dikes require very close spacing on tight bends, and the necessity of repair in Reach 9 is an example of this malady for bendway weirs. No evidence was noted that the stone was too small for the imposed shear stress. In Reach 13 the four rows of willows failed due to excessive scour of the toe material. Willows were exposed to the flow with no soil covering the potential roots.

With the exception of Reach 9, bendway weirs have functioned adequately with R_c/W values of from 1.89 to 2.77. No repair of willow post stabilization has been required with R_c/W values from 1.03 to 1.50, except on Reach 13.
